OCTOBER 18, 2015

# Watershed Week in Review

Llano River Watershed Alliance

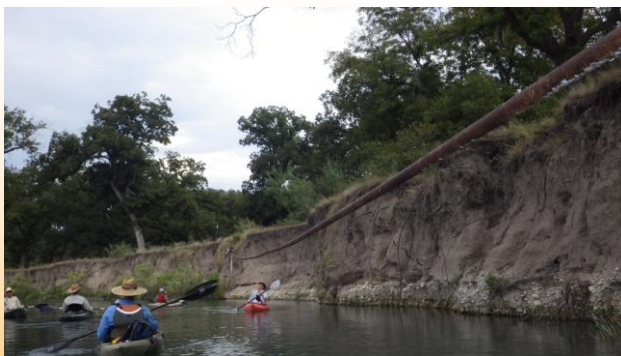
If you have had the opportunity to enjoy the South Llano River Paddling Trail, you can't but notice the unusual site of the suspended pipe on the right bank. This pipe was likely an irrigation line that used to sit more than 100 yards away from the river. However, due to significant erosion it is now suspended above the river (image above).

Too much sediment in the river is causing the South Llano to increase its meandering, increasing streambank erosion and exacerbating the problem. Part of the problem is runoff to the river from drought-plagued uplands. A related problem is the lack of a good rise to help flush the system. The last major flood event was in 2004. Since that time, there have been no floods on the South Llano above what is considered minor flooding (gage height 16 feet) by the National Weather Service. A flood warning for the South Llano has not been issued since 2010 when the river crested at 13 feet, or 18,000 cubic feet per second.
