# Water Samples from Homes Near Construction Blunder Were Found to Contain Trace Metal Levels that Exceed EPA Drinking Water Standards

# Preliminary and limited interpretation of groundwater-quality data pursuant to leakage of drilling fluids from a Kinder Morgan construction site

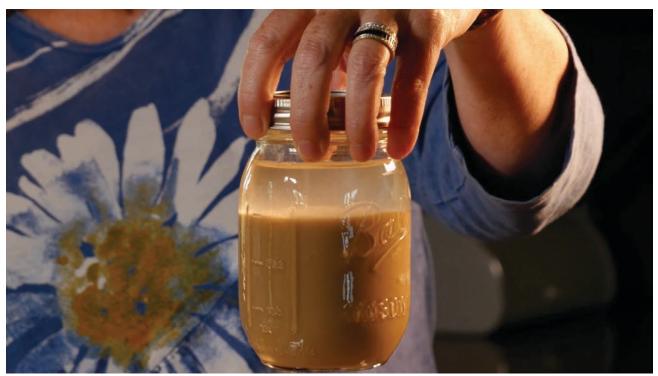
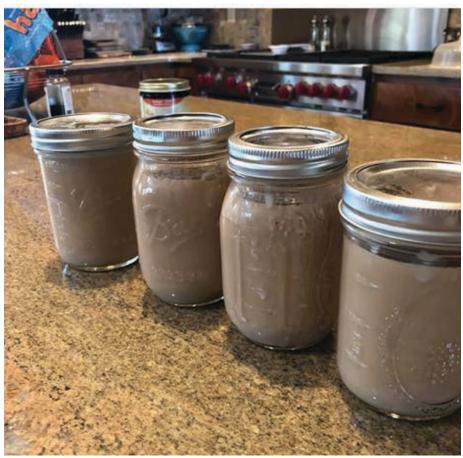
**WIMBERLEY, TX** Three days following the March 28 underground loss of 36,000 gallons of drilling fluid during construction of the Permian Highway Pipeline in Blanco County, two affected homeowners captured well samples of their chocolate-colored drinking water and had the samples delivered to LCRA Environmental Laboratory Services in Austin for testing and analyses.
