# **Permanent Stormwater Pollution Prevention Systems within the Edwards Aquifer Recharge Zone in Bexar County, Texas**

*An Overview and Assessment of Current Regulatory Agency Processes*

Greater Edwards Aquifer Alliance  
February 2010

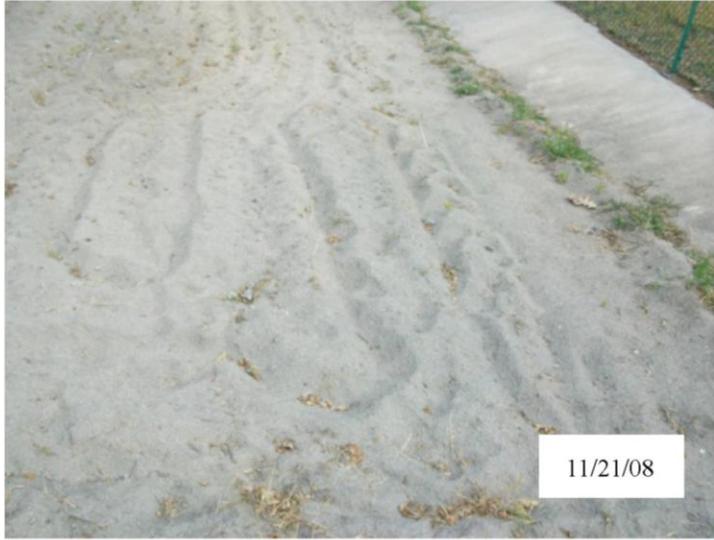
The inspector believes a walk behind tiller was used to level the sand filtration bed, which would mix any deposited sediment into the filtration media.

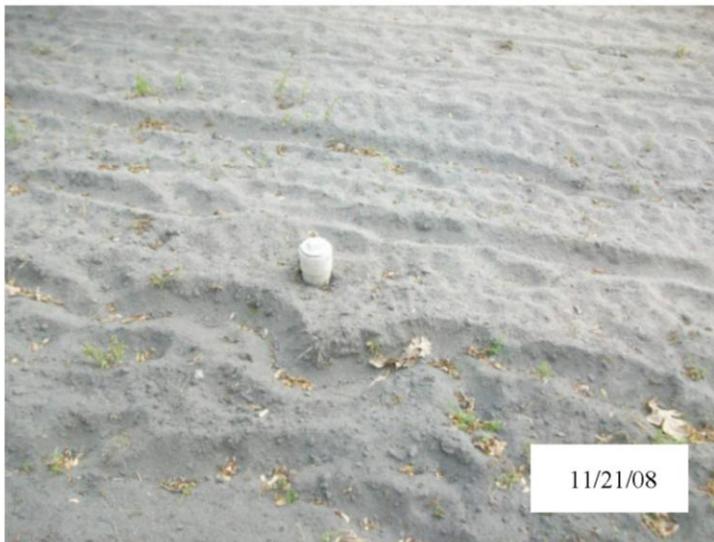
Staff found the basin's filtration media to have a strange grayish brown color.

- 6.) The filtration basin doesn't appear to be constructed of the right filter material. Instead of the washed concrete sand called for by the Technical Guidance Manual, staff found the filter material to have a very high concentration of fine sediment particles.

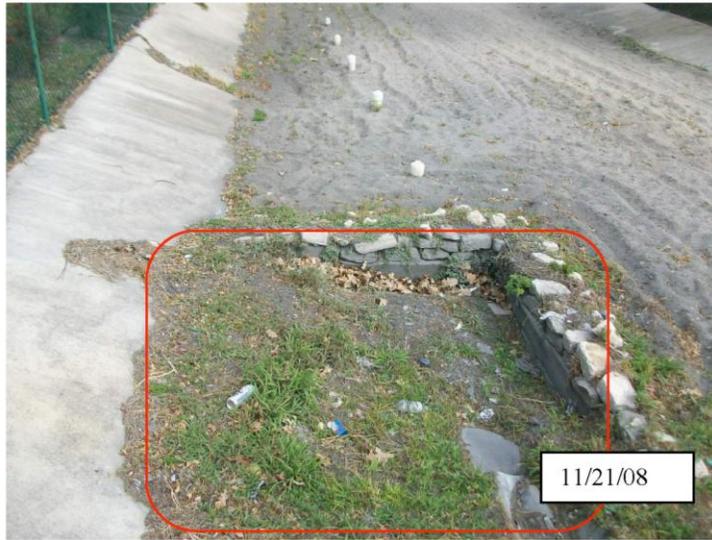
While inspecting the basin the inspector found heavy accumulation of sediment, debris, and vegetation within the splash pad.

- 7.) The heavy amount of sediment and plant debris that has accumulated within the splash pad causes the inspector to believe that basin maintenance has not occurred at the facility in some time.

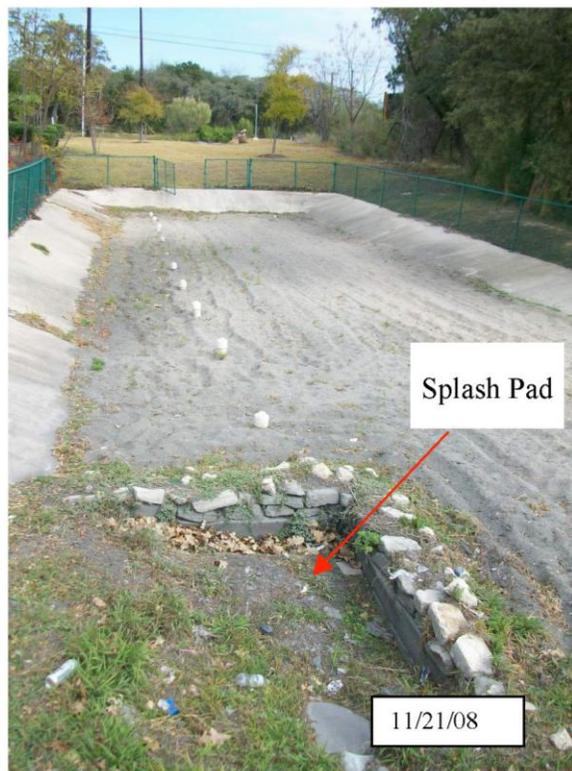
Staff was puzzled by the design of the basins splash pad. Further research was conducted to determine design characteristics.

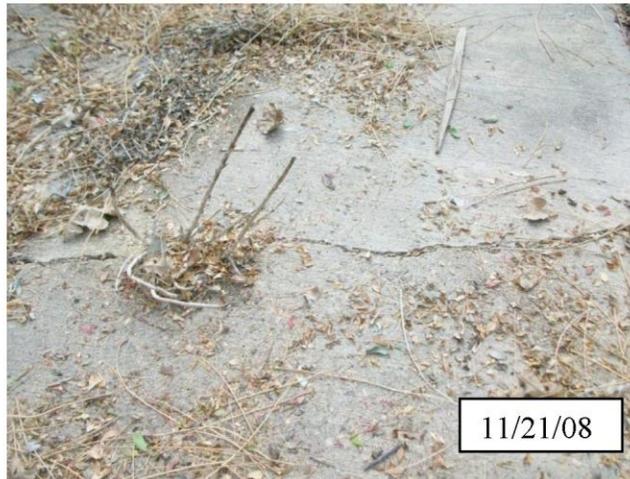
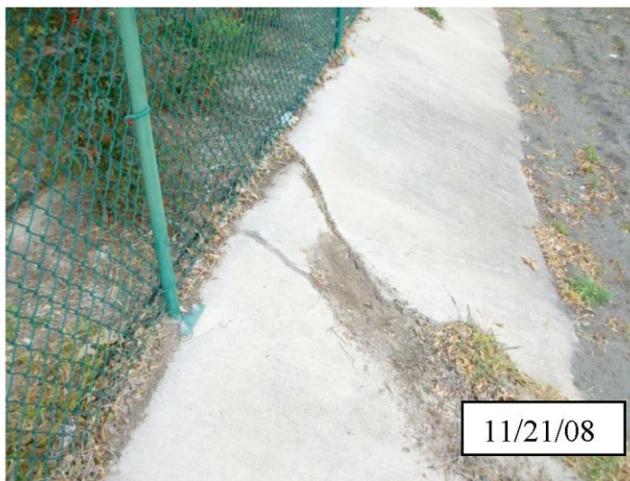
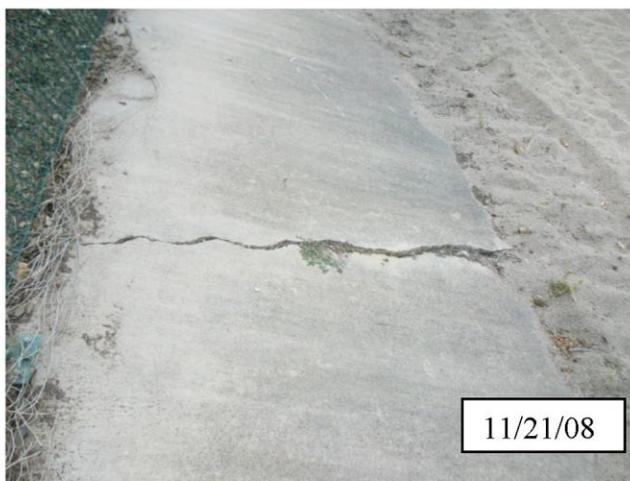
Here you can see just a few of the large cracks found in the side wall of the basin. These cracks could allow stormwater to exit the basin untreated by the filtration system.

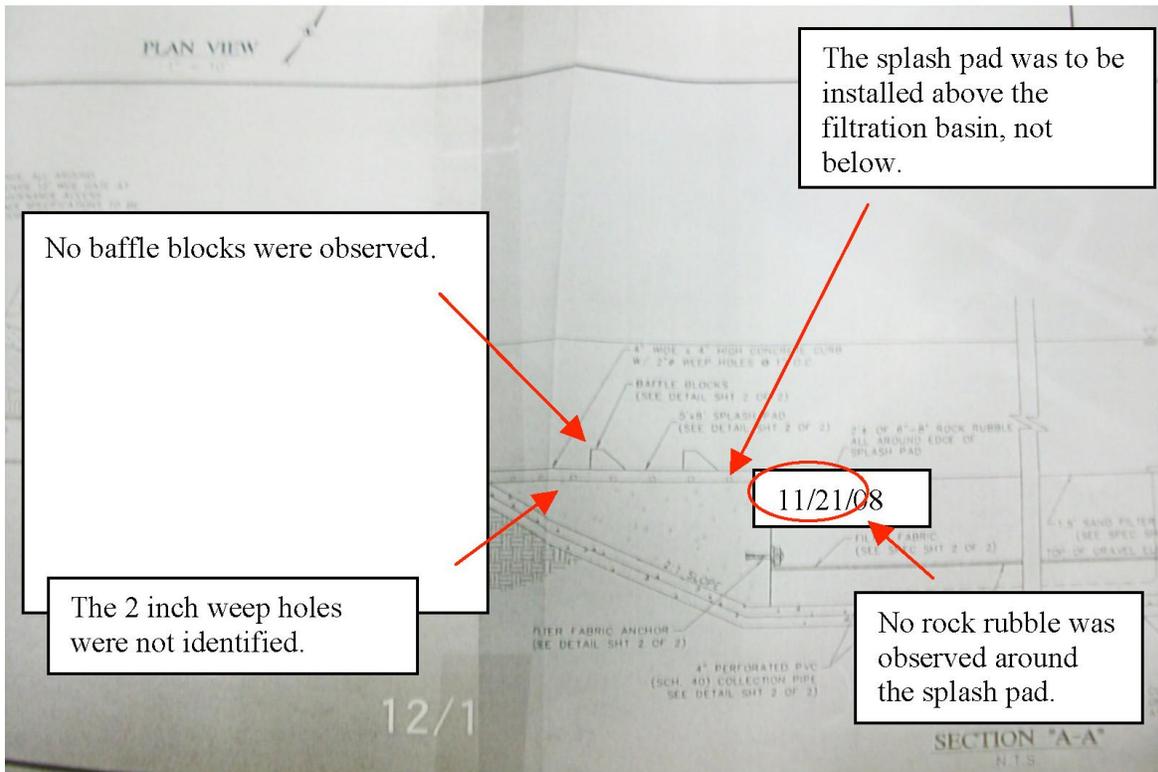
Both of these images were taken during the 12/10/08 TCEQ file review. The photo above shows a side view of the splash pad.

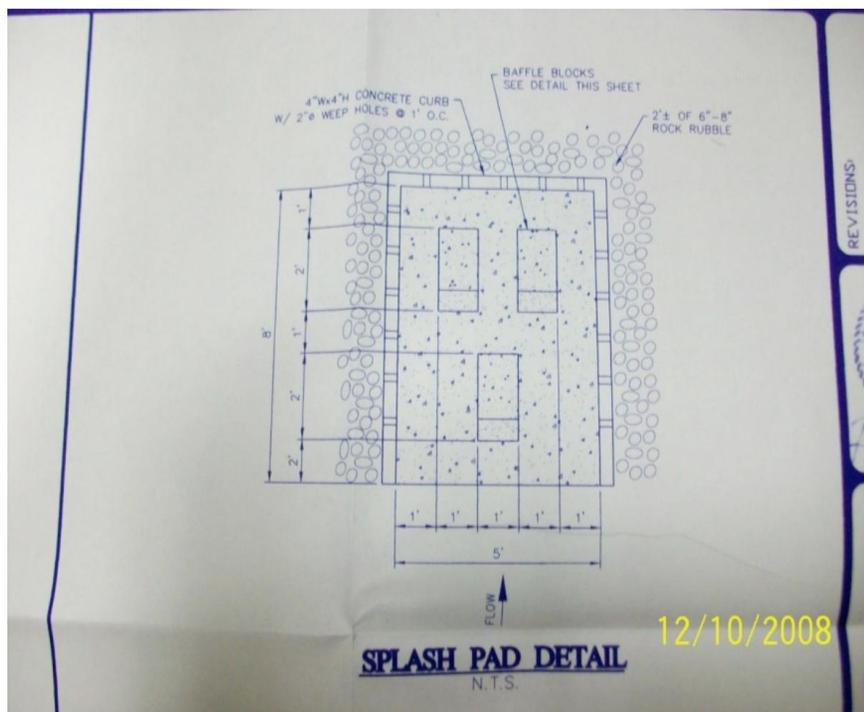
Here you can see a detailed view of the splash pad.

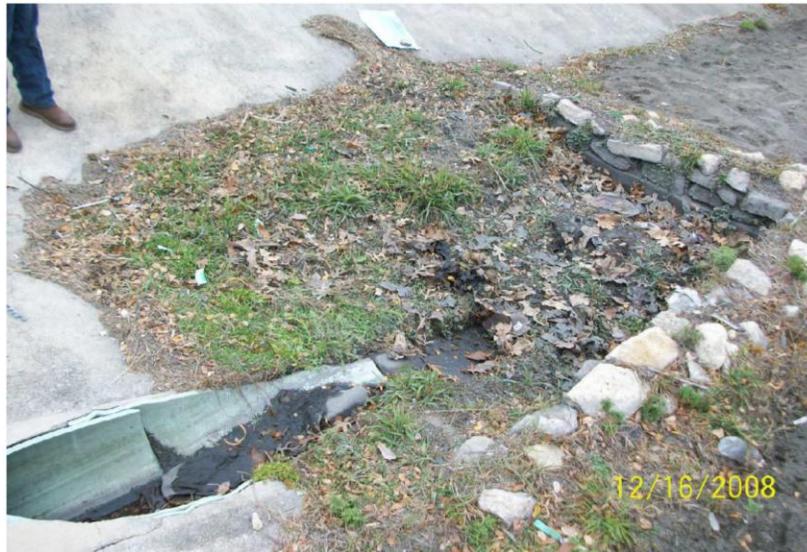
The plan called for two feet of 6” to 8” rock rubble was to surround the splash pad. No rubble was observed. Instead rocks had been stack atop the above mentioned curb. Baffle block were to be installed within the splash pad, none were observed.

- 3.) Two feet of six to eight inch rock rubble was to surround the splash pad. No rubble was observed. Instead rocks had been stack atop the above mentioned curb. The stacked rock was not part of the approved splash pad design.

- 4.) The approved plan called for baffle blocks to be installed within the splash pad. None were observed.
- 5.) The rock rubble around the overflow structure was found to be overgrown with grass; staff questions the effectiveness of the rock rubble.

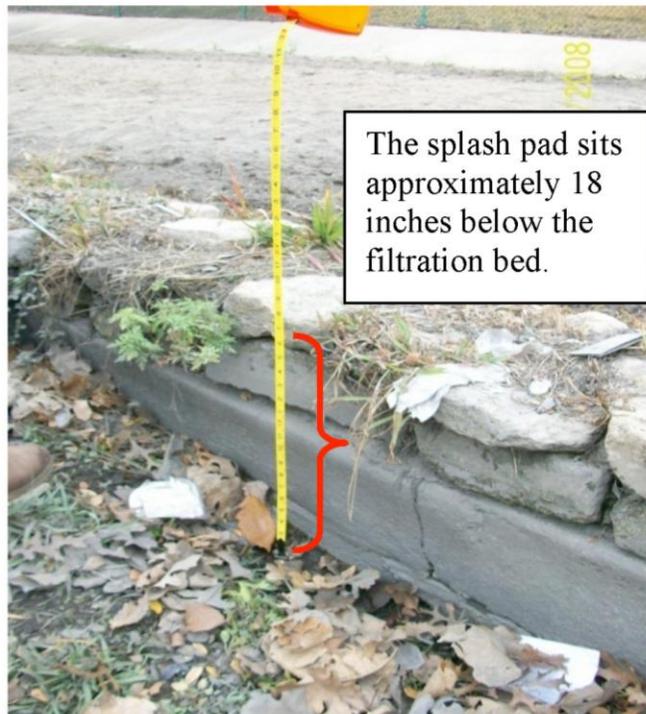
The splash pad was constructed below the filtration bed. A 4”X4” concrete curb with two inch weep holes was to be constructed around the splash pad. A concrete curb was identified, but the weep holes were not observed.

- 1.) The splash pad was constructed below the filtration bed. The approved design shows the splash pad was to be installed above the filtration bed.
- 2.) A 4"X4" concrete curb with two inch weep holes was to be constructed around the splash pad. A concrete curb was identified, but the weep holes were not observed. The size of the identified curb could not be determined.

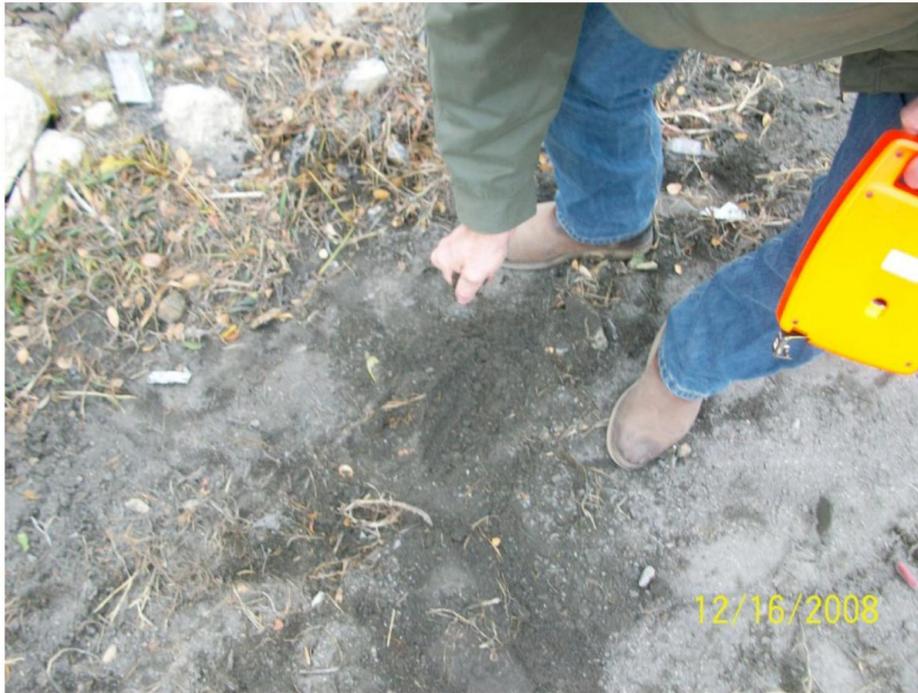
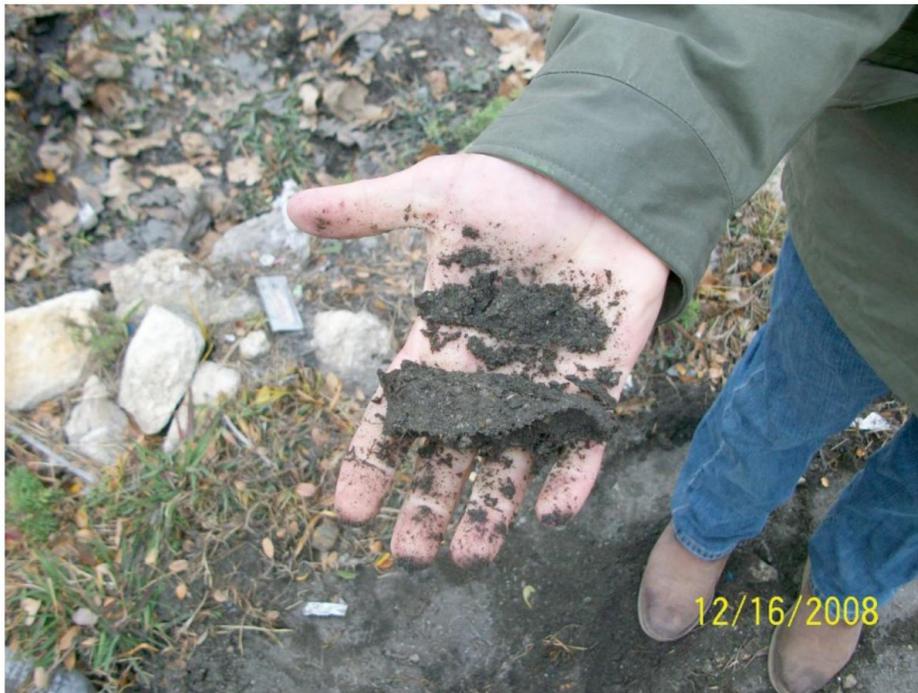
The filter media appears to have a high concentration of fine particles, instead of the washed concrete sand required in the Technical Guidance Manual.

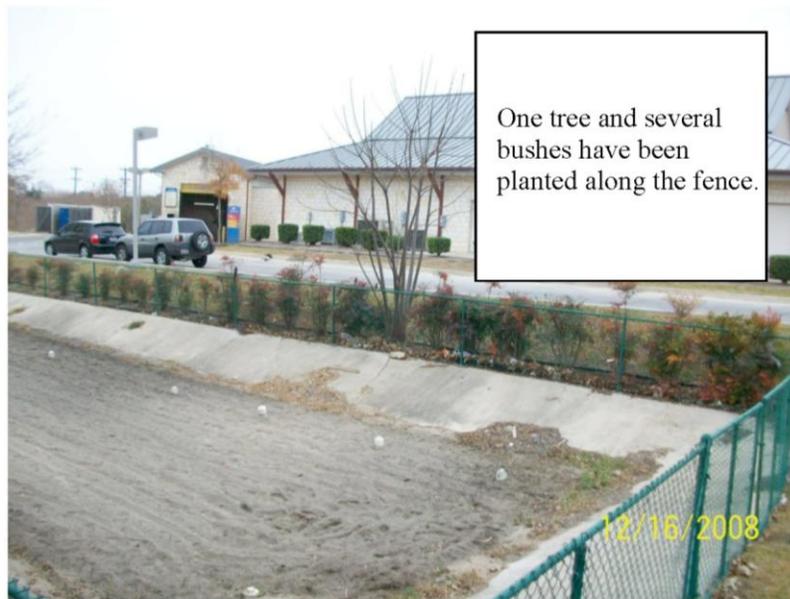
The approved plan called for a chain link fence to be constructed at the top of the basin. Instead CEC set a letter informing the TCEQ that the contractor installed the fence at the top of the concrete to facilitate installation and allow for landscaping maintenance operation to take place outside of the fence.

- The plans called for a concrete lined basin up to the top of the sand layer, and then a sod topped clay liner from that point up to the top of the basin. To facilitate construction and to reduce the potential for damage to the concrete the contractor extended the concrete liner up the side slope to a point 1/2 foot to 1 foot below the top of the slope. From that point a one foot clay liner was installed and then topped with sod.
- The plan calls for a chain link fence to be constructed at the top of the basin. The contractor placed the fence at the top of the concrete to facilitate installation and allow for landscaping maintenance operation to take place outside of the fence.

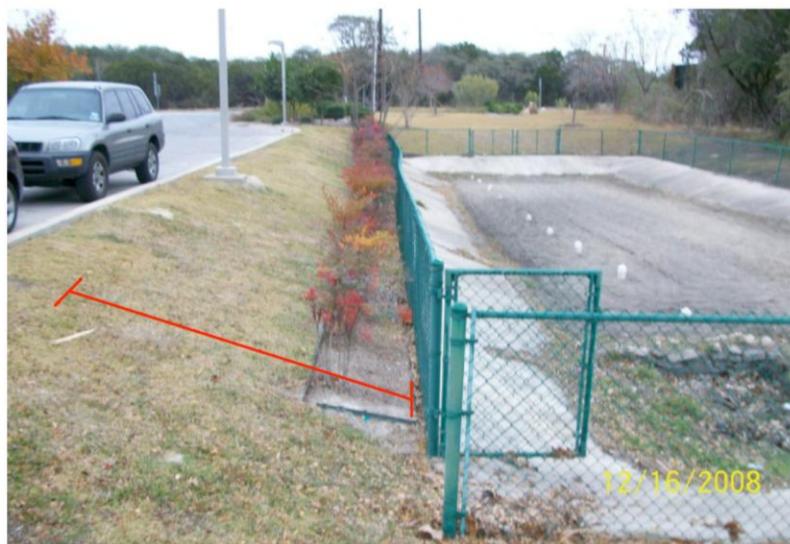
The letter also informed the TCEQ that the contractor extended the concrete liner up the side slope to a point  $\frac{1}{2}$  to 1 foot below the top of the slope. The area seen highlighted above is greater than 1 foot, why does the concrete not continue to a point  $\frac{1}{2}$  to one foot below the top of the slope?

EAA staff would like to know where the top of the basin is located. If the top of the basin is  $\frac{1}{2}$  to 1 foot below the top of the slope then it appears that the fence post, decorative tree and bushes are within the basin. If the tree, bushes, and fence post are within the basin, did the installation of the fence post and/or have the plants roots penetrated the one foot clay liner and geotextile fabric that was installed below the sod?
