## Riparian Restoration on Farms and Ranches in Texas

## Introduction

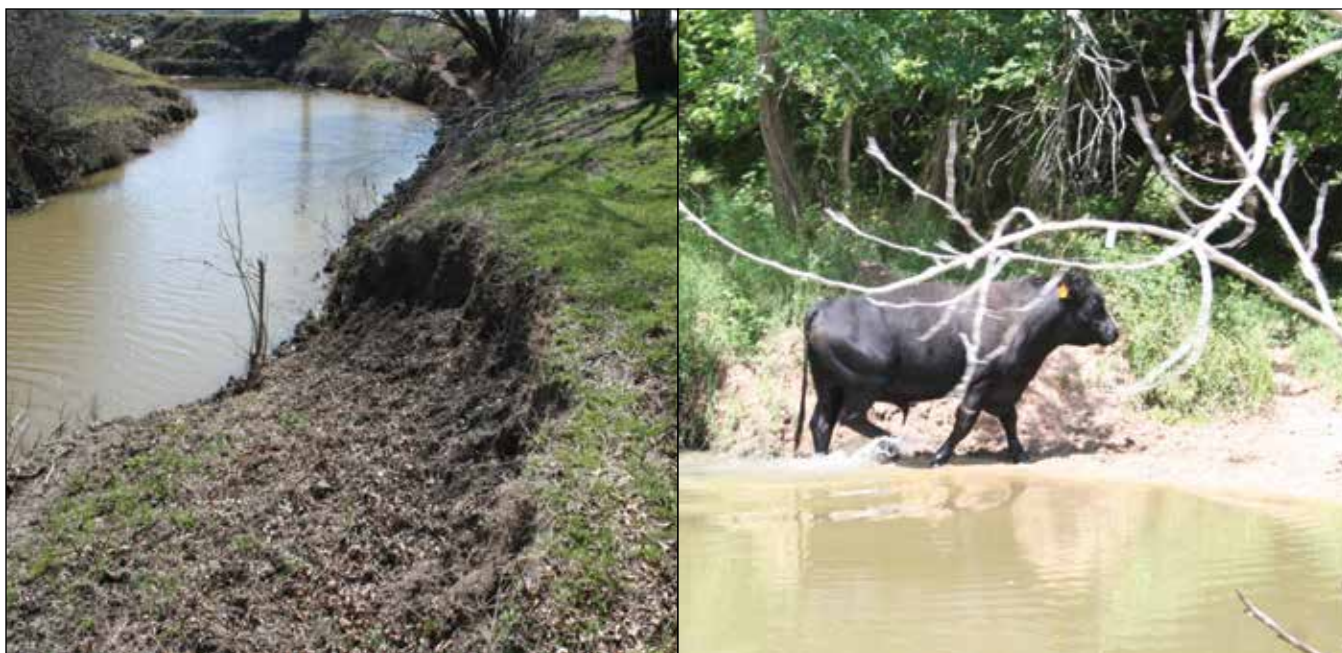
**Figure 1.** If not managed properly, cattle traffic can lead to erosion of streambanks (left) and deposition of fecal matter in waterways (right). Photos by Blake Alldredge and Mark Tyson, Texas A&M AgriLife Extension Service.

- Overgrazing that leads to a reduction in plant cover and vigor, and alteration of species composition and diversity (Kauffman and Krueger, 1984);
- Trampling of banks that results in accelerated stream bank erosion (Figure 1a);
- Soil compaction from livestock traffic that increases runoff and decreases infiltration and water available to plants; and
- Deposition of fecal matter in the stream leading to high levels of bacteria (Figure 1b; Wagner et al. 2013).

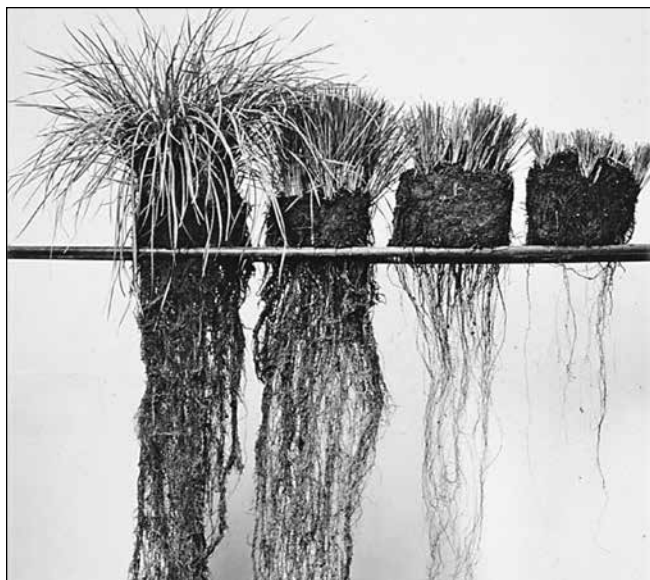
**Figure 2.** As grazing pressure increased, root biomass decreased. The second plant from left has 50% of the top growth removed with little effect on roots. An increase in grazing pressure results in dramatic loss of root development as seen in both plants on the right. From Crider (1955).

Overgrazing of riparian vegetation and plowing too close to the stream can affect bank stability because the removal of above-ground plant growth results in a decrease in root biomass, which physically binds the soil together and makes the soil up to 20,000 times more resistant to erosion (Figure 2; Crider, 1955; Thurow, 1991; Abernethy and Rutherford, 1998). Without the roots to hold soil in place, stream banks become vulnerable to erosion during flooding events. Overgrazing by cattle in the uplands can also impact riparian areas and streams, as decreased infiltration of rainfall into the ground results in greater volumes of runoff in streams and places additional pressure on the stream banks (Figure 3; Thurow, Blackburn, and Taylor, 1986; 1988). Riparian vegetation functions to slow down the overland flow and capture sediment,

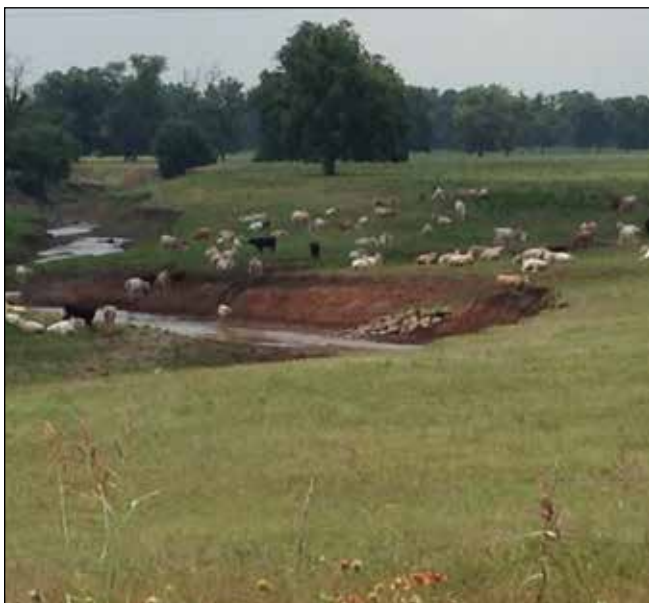
**Figure 4.** Allowing livestock to overgraze riparian areas and trample banks is detrimental to bank stability and water quality. Proper grazing management improves both. Photo by Blake Alldredge, Texas A&M AgriLife Extension Service.

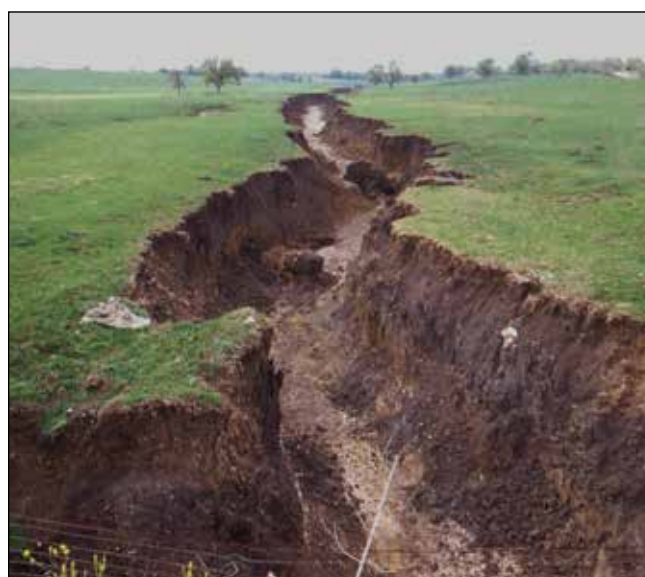
**Figure 5.** Poor riparian management has led to extreme downcutting in this creek. For reference, the block of soil closest to the camera is the size of a refrigerator. Photo by Kenneth Mayben, Natural Resources Conservation Service.

contributed in a watershed (Figure 5; Wynn and Mostaghimi, 2006). The Texas Water Development Board (2009) calculated that the Richland-Chambers Reservoir in Navarro County loses 2,065 acre-feet of water capacity every year for a total loss of 43,361 acre-feet in the 20-year period since 1987, when it was impounded. Consequently, enough sediment has accumulated during that 20-year period to cover the bottom of the 43,384-acre reservoir to an average depth of one foot (Figure 6). Texas A&M University researchers estimate that 84% of the sediment reaching the reservoir every year is from channel and stream bank erosion (Wang et al. 2010).

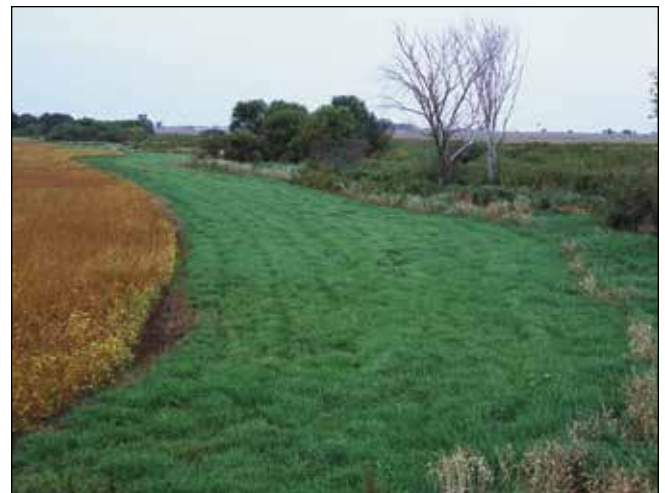
**Figure 7.** Riparian buffers protect creeks by reducing water velocities and capturing sediment from croplands. Photo courtesy of USDA – Natural Resources Conservation Service.

A riparian buffer is defined as a vegetated strip lying between agricultural land and a neighboring watercourse (Figure 7; Collins et al. 2009). Studies indicate that riparian buffers are an effective best management practice (BMP) for reducing nonpoint source pollution (NPS) in agricultural areas. These buffers and other agricultural BMPs can help prevent and/or minimize the effects of NPS by reducing erosion and pollutant loads that would otherwise reach the stream. In some cases, riparian buffers of only 32 feet in width can reduce phosphorus levels up to 95% (Vought et al. 1995), and nitrate levels up to 80% on row crop fields (Schultz et al. 1995). In addition, buffers as narrow as 20 feet can prevent up to 95% of the sediment eroded from uplands from reaching streams (Collins et al. 2009). Likewise, riparian buffers can benefit wildlife populations by providing corridors that connect habitats and allow safe movement between fragmented

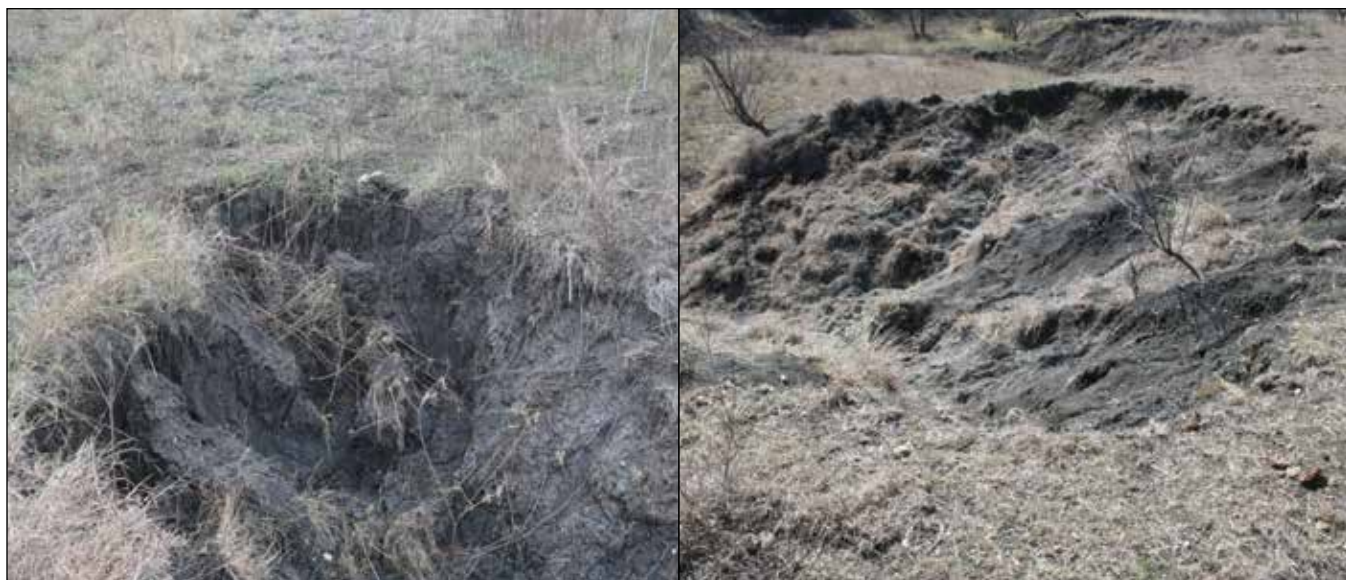
**Figure 8.** Active headcuts (left) and gullies (right) are a sign of active erosion and should be given special attention during planning. Photos by Blake Alldredge, Texas A&M AgriLife Extension Service.

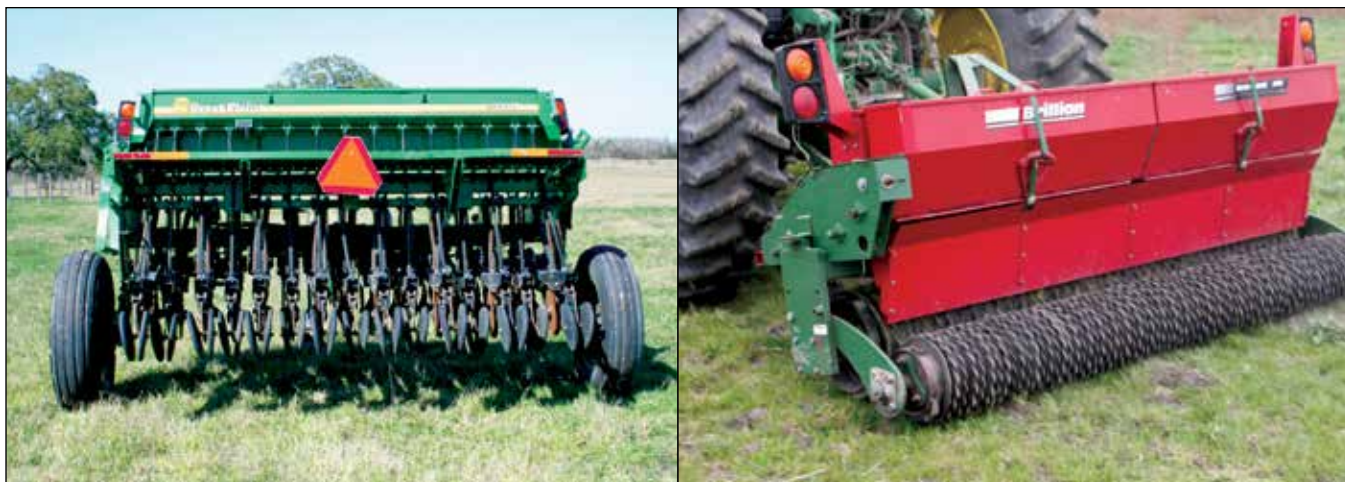
**Figure 11.** No-till seed drills (left) and cultipackers (right) are commonly used for restoring native prairies. Photos by Blake Alldredge, Texas A&M AgriLife Extension Service.

or other implement to firm the seedbed (Figure 11). This method typically costs from \$100 to \$200 per acre, depending mainly on seed prices, which are the greatest expense. Even though this method is more expensive than passive restoration, given the right conditions, a productive stand of native prairie plants can be established within two to three years. In contrast, if it is determined after two years of passive restoration that the native seedbank is not sufficient, then active restoration techniques would need to be used to establish a native prairie plant community which may take an additional two to three years.

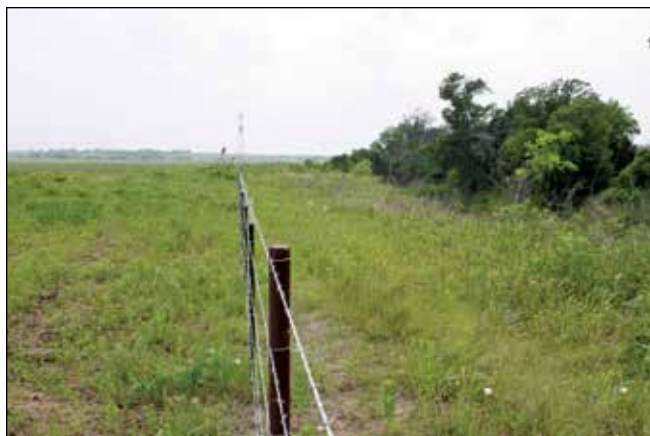
**Figure 12.** This riparian fence could be moved back 200 to 300 yards to create a riparian pasture. Photo by Blake Alldredge, Texas A&M AgriLife Extension Service.

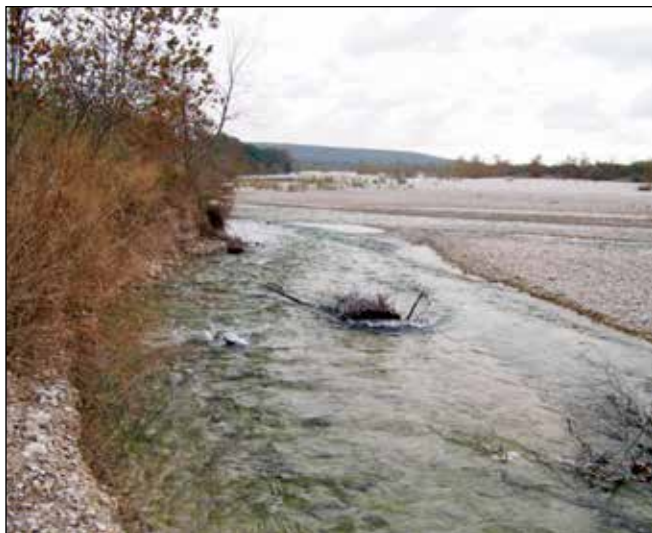
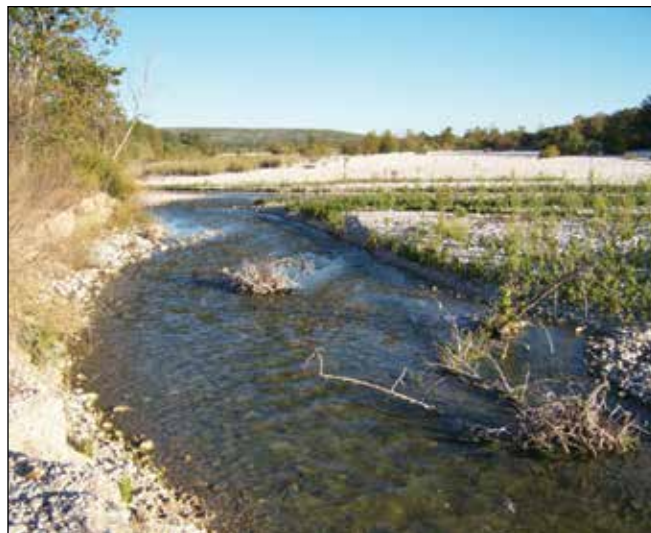
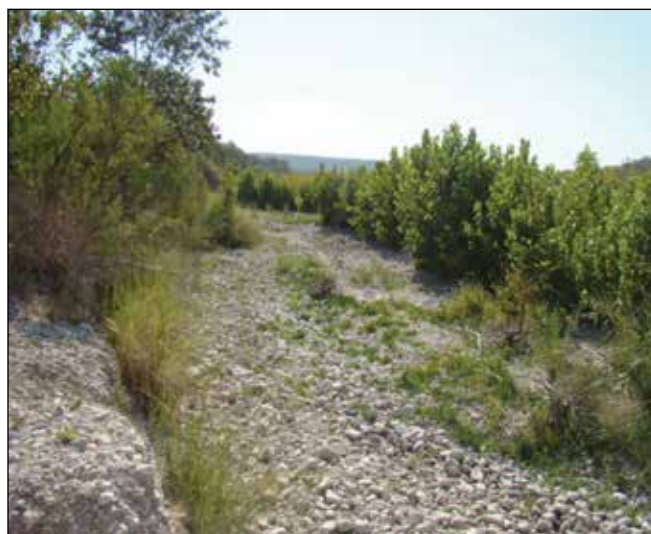
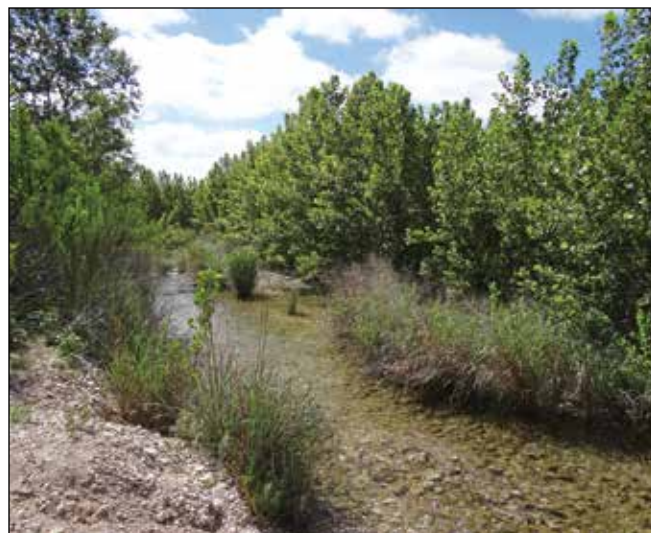
**Appendix B.** Example of photo point monitoring along the Nueces River after the prohibition of off-road vehicles in the riverbed. Photos by Sky Lewey, Nueces River Authority.
